Citizen Stream Monitoring Data Summary

Grant-Platte River Basin 2000-2003

Compiled as part of the University of Wisconsin-Extension's and the Wisconsin Department of Natural Resources' Water Action Volunteers' Stream Monitoring Program

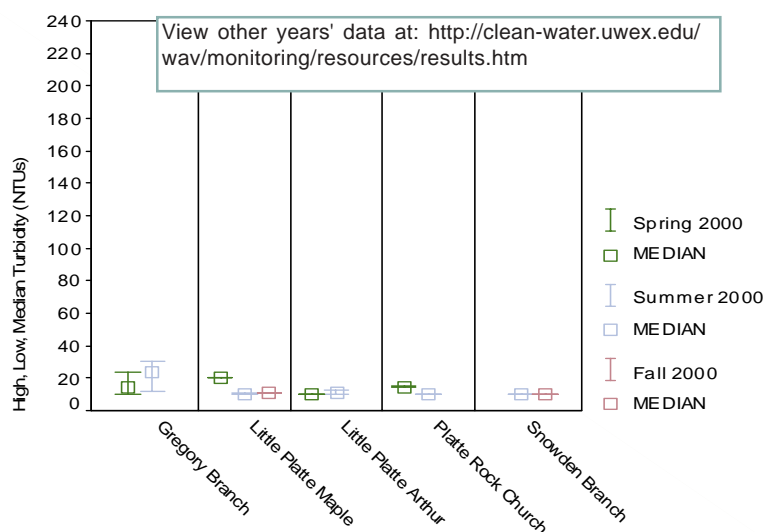
Turbidity was measured monthly. In the chart below data were compiled to show low, median and high turbidity values at each site for year 2000 sampling (other years' data are available for viewing online at: the web address shown on the chart). Sites are on the horizontal axis while turbidity (NTUs) is plotted on the vertical axis.

Between 2000 and 2003, turbidity was most often <10 NTUs (plotted as 10 NTUs for graphical purposes), which indicates those sites had good water clarity, with no negative effects on aquatic life.

Within the four year time period, only four monitoring visits found turbidity values that exceeded 85 NTUs*. These were at both sites on the Little Platte River, Rountree RR, and at Snowden Branch. The turbidity was only >240 NTUs at Little Platte Arthur and Snowden Branch when it was raining during spring 2002. Prolonged turbidity levels of this magnitude can have a negative effect on aquatic life.

Fish begin to show signs of stress when turbidity is

>10 NTUs and up to 100 NTUs when such levels persist for a number of hours. When turbidity exceeds 100 NTUs for hours or days fish can experience increased respiration,

cover abandonment, or reduced feeding. The fact that it was raining when highest turbidity values were recorded suggests that streamflow and erosion were affecting turbidity (and not, say, something such as construction near the streams). A next step might be to investigate sources of and ways to mitigate areas where erosion is occurring. Additional monitoring to assess how long turbidity values stay elevated following a storm event is also an important next step.

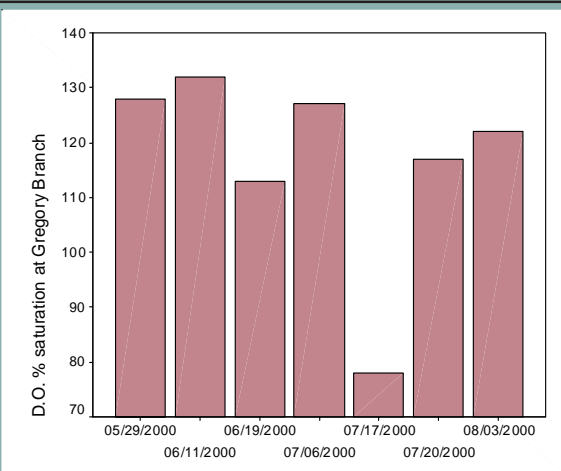
Dissolved Oxygen

At Gregory Br. D.O. was always monitored mid-afternoon, except July 17, 2000, when it was tested at 5:30 A.M. Because D.O. varies daily, based on such factors as sunlight and temperature, it is expected to be lowest just before sunrise. The results in the chart give a glimpse into the daily D.O. range in this stream.

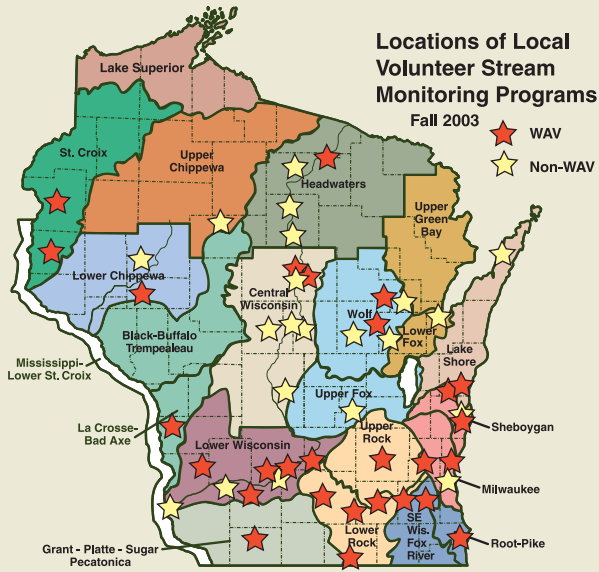
Extent of Volunteer Stream Monitoring in Wisconsin

Across Wisconsin citizens are monitoring water quality in wadable streams using Water Action Volunteers' (WAV) methods. As of November 2003, over 250 monitoring sites were registered in the statewide database. The map above shows locations of local stream monitoring programs including both WAV and non-WAV efforts.

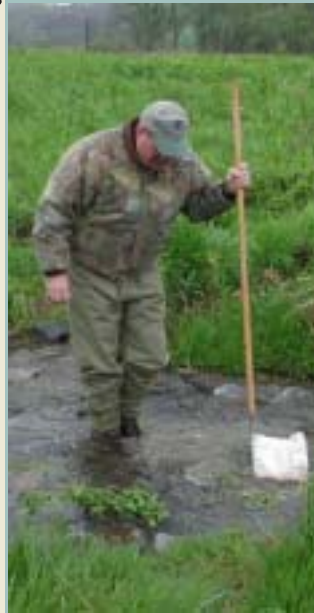
Grant-Platte Basin Monitoring Sites

In the Grant and Platte Rivers' Basin, 8 streams and eleven sites were monitored between 2000 and 2003.

1. Blockhouse Creek at Cty O
2. Gregory Branch off Cty F Little Platte River (2):
3. upstream from Arthur WI
4. upstream from Maple Ridge Rd
5. McPherson Cr., up Airport Rd Platte River (2):
6. at Annaton Rd bridge
7. downstream Rock Church Rd Rountree Branch (2):
8. at railroad trestle bridge
9. at Southwest Road
10. Snowden Branch, upstream from Big Patch Road
11. Unnamed Cr. at Compton's

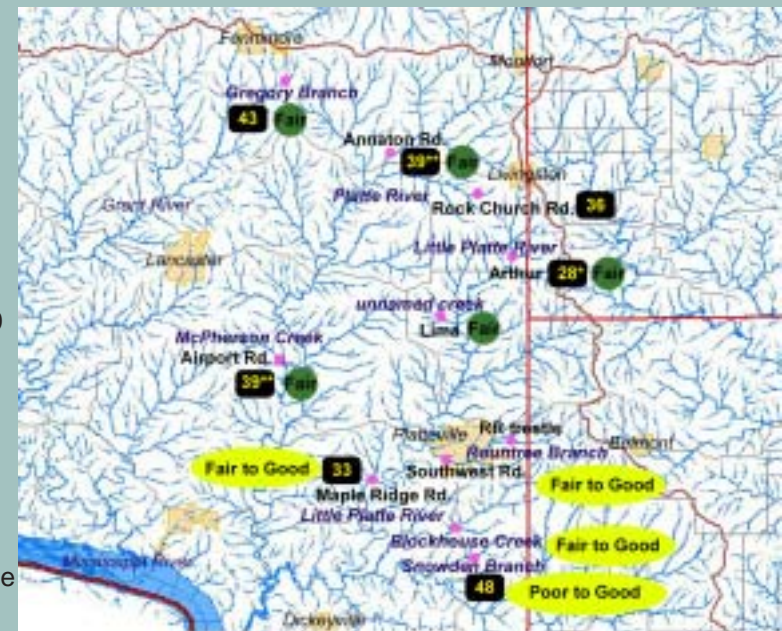
Biotic Index scores are based on macro-invertebrates' tolerance to varied oxygen levels in the water. The scores range from 1 to 3.6 or greater, and a stream is assigned a water quality health rating based on its score. Ratings range from poor to excellent (see box at right).

The map to the right shows sampling sites monitored in the Grant-Platte Basin between 2000 and 2003. The sites are marked with pink dots. B.I. water quality ratings are marked in green or yellow ovals.

Over the four year sampling period, scores ranged from 1.7 (Nov '01) to 2.7 (Oct '00); Both scores were found at Snowden Br. Most B.I. scores in the Basin indicated fair water quality conditions.

At the more southern sites, good quality ratings were found, with very high 'fair' ratings or good ratings during each of 3 visits at both Blockhouse Creek and Rountree Br. at Southwest Road.

Habitat assessment scores are marked on the map below in the black rectangles. Scores ranged from 28 to 46. Habitat scores can range between 13 and 52. Because watershed specific characteristics (e.g., land slope, soils) can affect the score, it's best to compare scores year to year within a watershed. Thus, the scores below give a basis of habitat quality at the site that may be used in the future.
