Citizen Stream Monitoring Data Summary

Rock County 2002

Compiled as part of the University of Wisconsin-Extension's and the Wisconsin Department of Natural Resources' Water Action Volunteers' Stream Monitoring Program

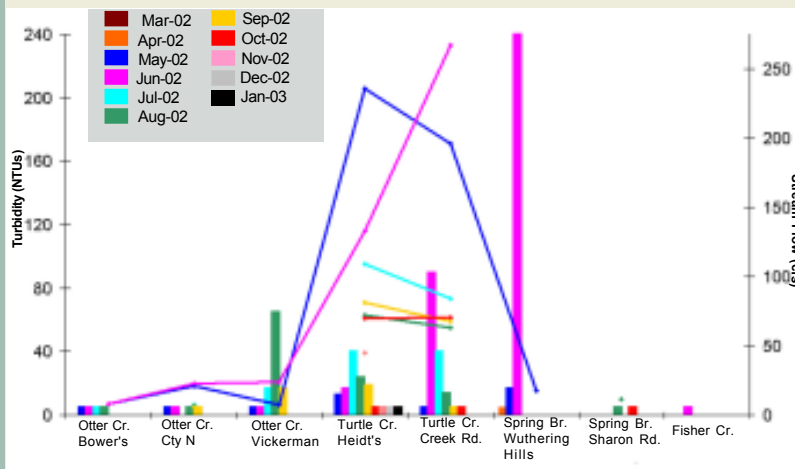
Turbidity was measured monthly and stream flow was measured occasionally. Flow is often directly related to turbidity, so both were plotted on the chart below to assess if any connection between the two was visible.

Sites are on the horizontal axis while turbidity (NTUs) and stream flow (cfs) are plotted on the vertical axes. Bars represent turbidity scores, and dots or lines represent stream flow. Compare lines and bars of the same color.

The best relationship between the two was during June 2002. The fuchsia bars and line show turbidity and flow increased similarly.

Turbidity was most often <10 NTUs (plotted as 5 NTUs for graphical purposes), which indicates those sites had good water clarity, with no negative effects on aquatic life.

However, at Otter Cr. (Vickerman Rd), Turtle

Cr. (Creek Rd), and Spring Br. (Wuthering Hills), turbidity was 65, 90 and 240 NTUs during June (latter two) and August (Otter Cr.). Prolonged turbidity levels of this magnitude can have a negative effect on aquatic life. Fish begin to show signs of stress when turbidity is greater than 10 NTUs and up to 100 NTUs when such levels persist for a number of hours. When turbidity exceeds 100 NTUs for hours or days fish can experience increased respiration, cover abandonment, or reduced feeding.

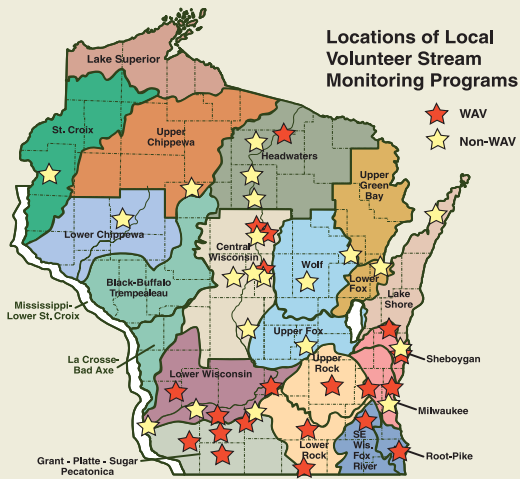
Extent of Volunteer Stream Monitoring in Wisconsin

Across Wisconsin citizens are monitoring water quality in wadable streams using Water Action Volunteers' (WAV) methods. As of March 2003, nearly 140 monitoring sites were registered in the statewide database. The map above shows locations of local stream monitoring programs, including both WAV and non-WAV efforts.
